# Detection of reinforcement in the non-traditional building structures - historical statues

**O Anton, L Vitek, V Hermankova, T Komarkova and P Cikrle**

Department of Building Testing, Faculty of Civil Engineering, BUT in Brno, Veveri 95, Brno, Czech Republic

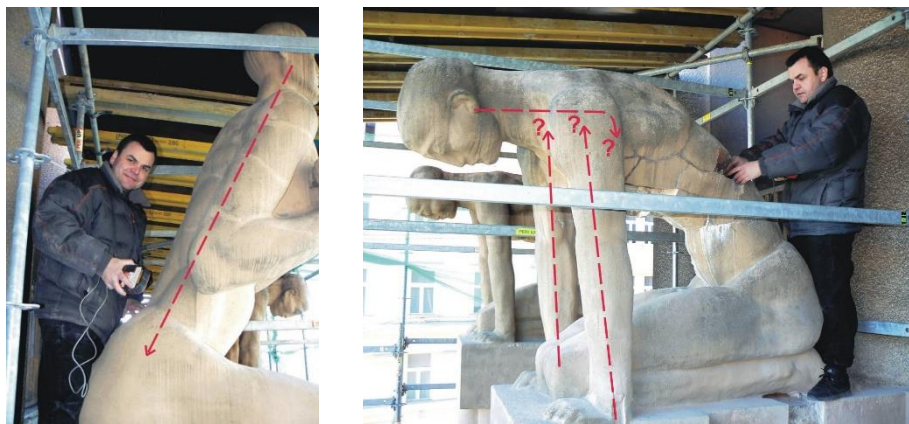
11 in Brno. It is the building of a former Regional Sickness Fund from 1925, and the author of the sculptures was Myslbek's pupil, academic sculptor Václav Hynek Mach. In the sculptures made from artificial stone, we detected only sporadic reinforcement with several smooth reinforcing bars with a circular cross-section of 20 mm, which are insufficient in terms of statics, as is apparent in figure 1.

**Figure 1.** Measurement of the position of reinforcement in individual sculptures from artificial stone in the sculptural group called Health. The detection of reinforcement was relatively precise, considering the low number of reinforcing bars. Nevertheless, it was not possible to precisely determine the location and method of anchoring of individual reinforcing bars [3].

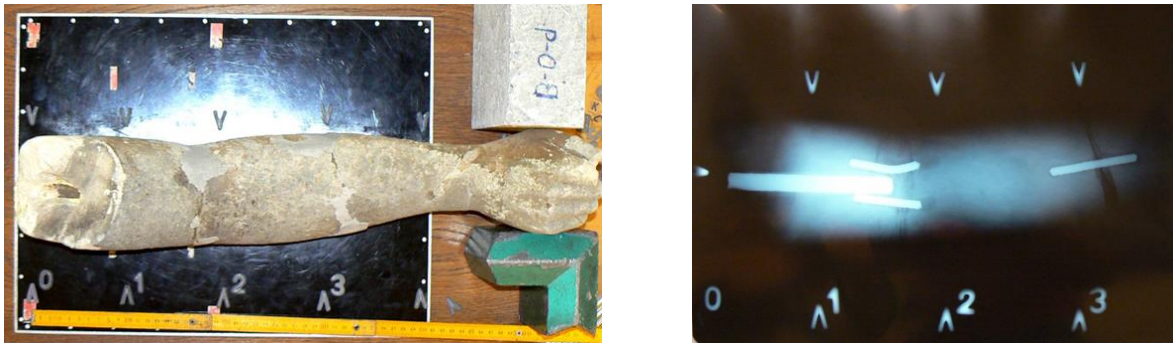
The radiology revealed that the original reinforcement consists of one, probably forged, rod-like element with a diameter of approximately 13 mm. This element originally linked the arm with the corpus of the statue and ended at the elbow level, in the plane of the first repaired fracture. The image of this reinforcing element is well apparent in figure 3 and also in figure 5. The reinforcement is located in the cavity with a diameter of approximately 20 mm which is sealed with sulphur. An additional reinforcement was detected at the point of the repaired fracture in the elbow. The reinforcement consists of two steel reinforcing bars with a diameter of approximately 6 mm and a length of approx. 53 and 55 mm. According to the surface finish of the reinforcement apparent on the radiogram, it is probably a cut piece of the Kari net for concrete.

It is well apparent on the radiograms that reinforcements were inserted into the holes pre-drilled in both fragments, and the holes exceed the inserted reinforcement by approx. 11 - 17 mm. From the image of the pre-drilled holes it is possible to assume that they are either not filled at all, or that they are filled with a material with a substantially lower density than the volume mass of the arm's sandstone. The image of these reinforcing elements is well apparent in figure 3 and 4.

Another additional reinforcement was detected at the point of the repaired fracture in the middle of the forearm. The reinforcement consists of one steel reinforcing bar with a diameter of 6 mm and a length of 70 mm. According to the surface finish of the reinforcement apparent on the radiogram, it is probably a cut piece of the Kari net for concrete.

It is well apparent on the radiograms that reinforcement was inserted into the hole pre-drilled in both fragments, similarly to the additional reinforcement 1. The image of this reinforcing element is well apparent in figure 3 and 4.

**Figure 3.** Radiography of the sandstone arm from shoulder to wrist in geometry 1, view from the x-ray tube (from the focus of irradiation), right picture: the resulting radiogram, well apparent metal connecting elements in both parts of the fracture (in the elbow and in the middle of the forearm) as well as the reinforcement ending in the elbow. The picture clearly shows also the pre-drilled holes for inserting the connecting elements in the fracture points. Also apparent is the hole in which the original reinforcement is placed, filled with sulphur.

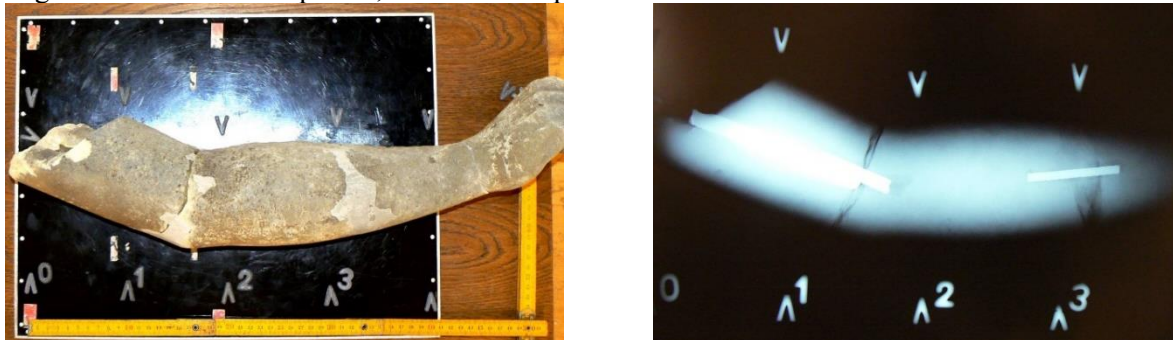
**Figure 4.** Radiography of the sandstone arm from shoulder to wrist in the control geometry 2, view from x-ray tube (from the focus of irradiation).

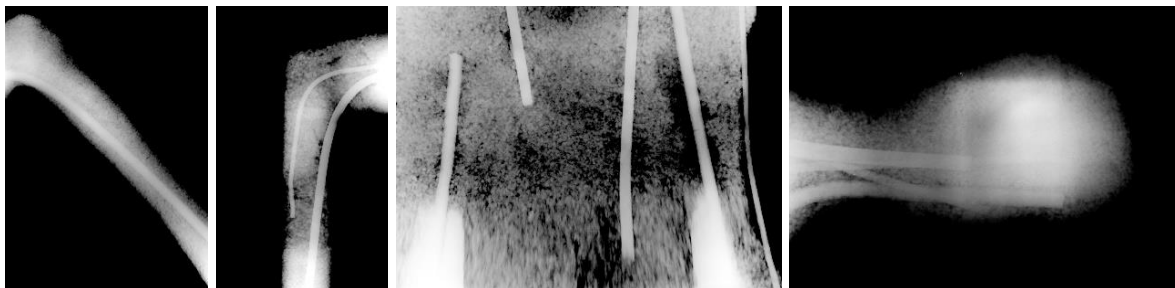
**Figure 6.** Examples of individual radiograms capturing reinforcement of individual sections of the sculpture.

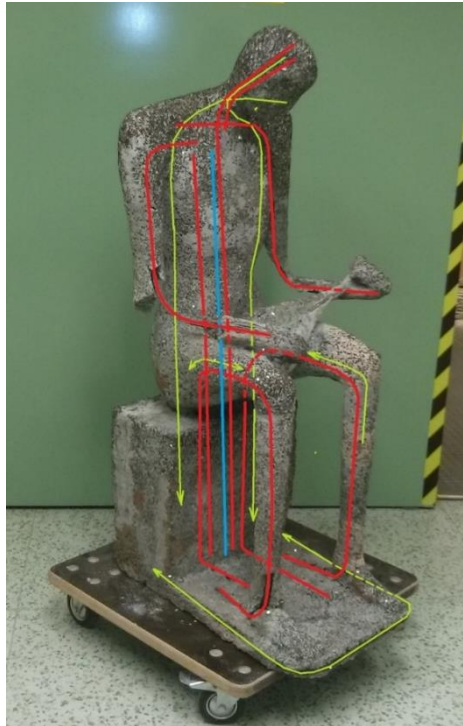
**Figure 7.** The anticipated pathways of the detected reinforcement in the sculpture. Red – rectangular cross-section of 10 x 10 mm, green – circular cross-section of  $\varnothing$  6 mm, blue – reinforcement with an unknown cross-section with a width (diameter) of min. 15 mm. Reinforcement of the mandolin and fingers with reinforcing bars of  $\varnothing$  6 mm is not captured in the picture.
