Anchorage length of patented wire cables in prestressed bridge girders

Svoboda A., Klusáček L., Nečas R., Koláček J., Strnad J., Olšák M.

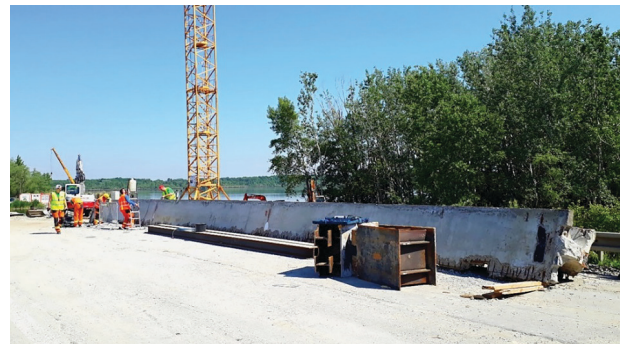
Fig. 1. A complete view of the 27-meter-long I-73 girder during performance of the experiments

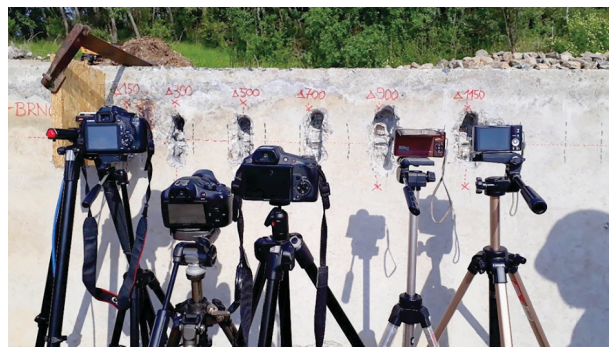
Fig. 2. A measuring set of digital cameras at the open semi-destructive probes during the experimental measurement of the anchorage length of a straight prestressing cable (EXP1)

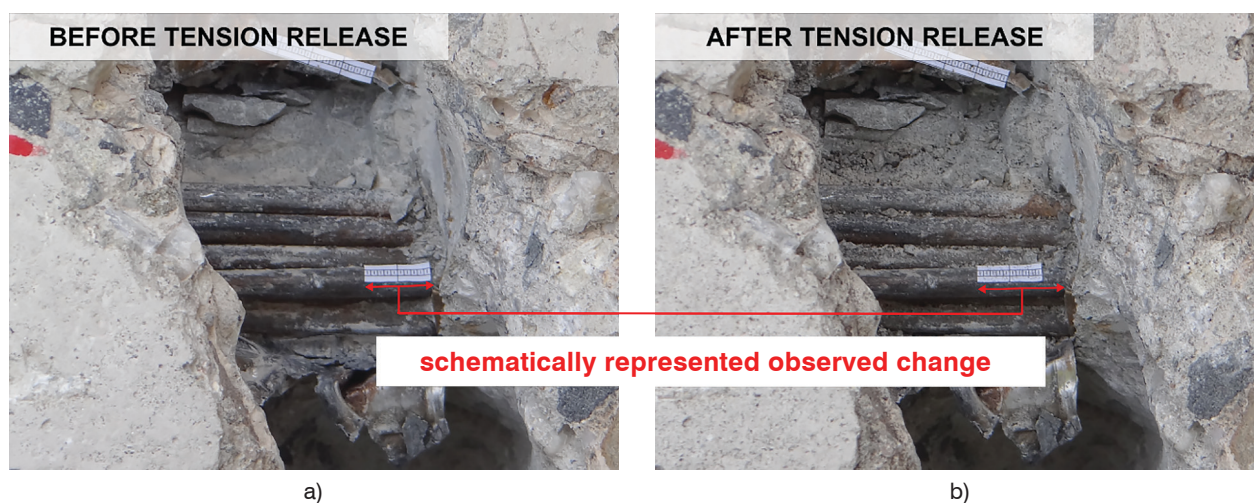
Fig. 3. A sample of images from the measuring of the slip of the I-73 girder prestressing reinforcement. The left image shows the condition before tension release, the right image shows the condition after tension release (after the performed slip)

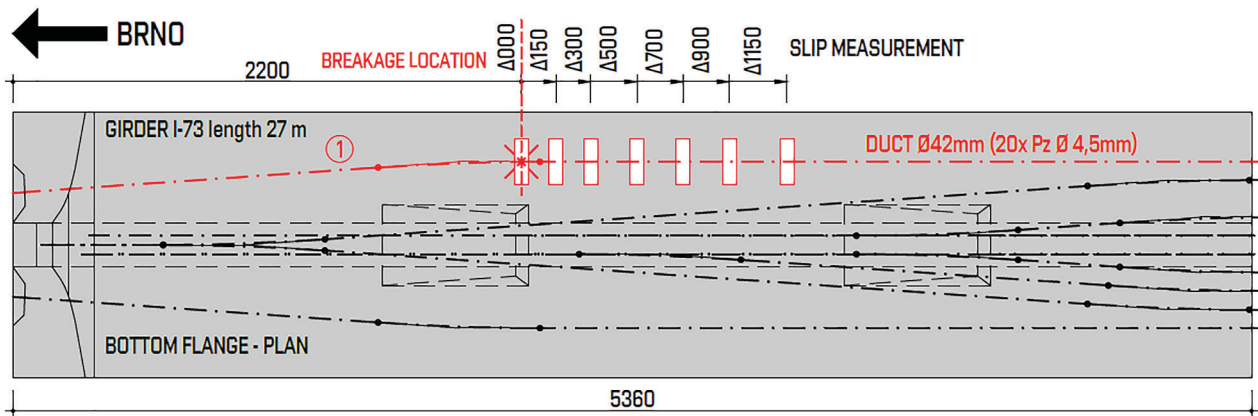
Fig. 4. Schematic illustration of the experimental measurement of the straight cable anchorage length (denoted EXP1) In the case of EXP2, the measurements were made symmetrically to EXP1 with the axis of symmetry drawn in the middle of the girder span
