# Detection of reinforcement in the non-traditional building structures - historical statues

**O Anton, L Vitek, V Hermankova, T Komarkova and P Cikrle**

Department of Building Testing, Faculty of Civil Engineering, BUT in Brno, Veveri 95, Brno, Czech Republic

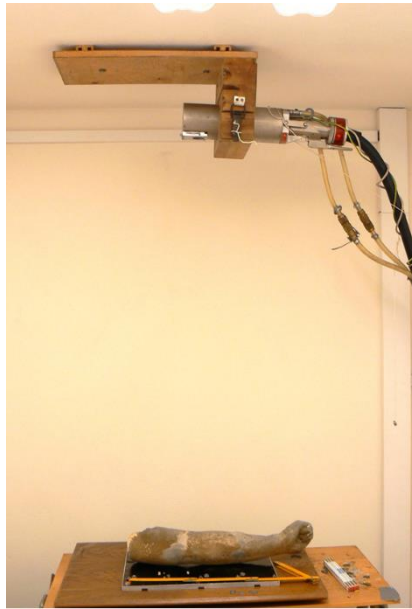
**Figure 2.** Radiography of the arm from the statue of Archangel Michael from Malešovice, above: x-ray tube of the Andrex CP 490 – 160 kV device, at the very bottom: cassette with an Agfa Testix C7 film.

The radiology revealed that the original reinforcement consists of one, probably forged, rod-like element with a diameter of approximately 13 mm. This element originally linked the arm with the corpus of the statue and ended at the elbow level, in the plane of the first repaired fracture. The image of this reinforcing element is well apparent in figure 3 and also in figure 5. The reinforcement is located in the cavity with a diameter of approximately 20 mm which is sealed with sulphur. An additional reinforcement was detected at the point of the repaired fracture in the elbow. The reinforcement consists of two steel reinforcing bars with a diameter of approximately 6 mm and a length of approx. 53 and 55 mm. According to the surface finish of the reinforcement apparent on the radiogram, it is probably a cut piece of the Kari net for concrete.

It is well apparent on the radiograms that reinforcements were inserted into the holes pre-drilled in both fragments, and the holes exceed the inserted reinforcement by approx. 11 - 17 mm. From the image of the pre-drilled holes it is possible to assume that they are either not filled at all, or that they are filled with a material with a substantially lower density than the volume mass of the arm's sandstone. The image of these reinforcing elements is well apparent in figure 3 and 4.

Another additional reinforcement was detected at the point of the repaired fracture in the middle of the forearm. The reinforcement consists of one steel reinforcing bar with a diameter of 6 mm and a length of 70 mm. According to the surface finish of the reinforcement apparent on the radiogram, it is probably a cut piece of the Kari net for concrete.

It is well apparent on the radiograms that reinforcement was inserted into the hole pre-drilled in both fragments, similarly to the additional reinforcement 1. The image of this reinforcing element is well apparent in figure 3 and 4.

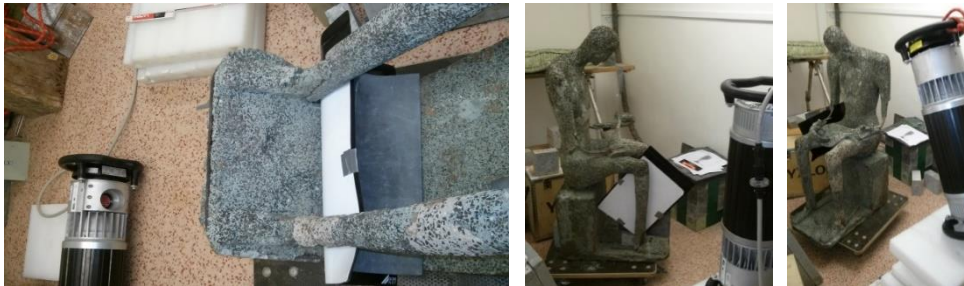
**Figure 5.** Radiography of an object with such a complicated shape whose individual parts have various widths, requires a number of exposures with different exposure parameters and irradiation angles.

The assessed object was irradiated in various directions across it key parts. During the irradiation it became apparent that considering the extreme type of aggregate used with a high shielding capability, the widths of certain parts of the sculpture (back, pedestal) were on the very edge of, or behind, the possibilities of the X-ray (high width and simultaneously small differences in the surface mass at points with and without the reinforcement). That is why it was possible to irradiate, step by step, only small sections of the sculpture, always with a markedly different exposure parameters suitable for the imaging of reinforcement in the given section. At the same time it is necessary to say that the sculpture's shape was so complicated that the irradiation of certain parts was not possible – it was not possible to determine the axis Radiation source – Object – Memory film without interfering with another part of the object. Examples of irradiation configurations, examples of radiograms and the anticipated position of reinforcement are shown in the following figures.
