Monitoring the long-term durability and microstructure of polymer concrete patching materials with high content of secondary raw materials using advanced methods

J Hodul, L Meszarosova and R Drochytka

Institute of Technology of Building Materials and Components, Faculty of Civil Engineering, Brno University of Technology, AdMaS Centre, Veveri 331/95, Brno 602 00, Czech Republic

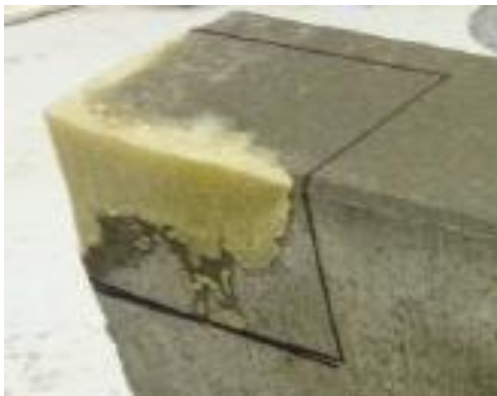
Figure 1. Sample of the PM-E patching mortar for CT Tomography.

3.2.2. CT Tomography. Using special computed tomography (CT) designed for building materials, it was possible not only to observe the microstructure of the test samples, but also to consider the internal structure and distribution of pores and filler. In our case, whether the influence of weathering on the reprofiled part of the concrete curb degraded the polymeric repairing substance was monitored. As a tomographic sample, a cut-off section of the reprofiled corner of the concrete curb was used (see figure 1 and figure 2).

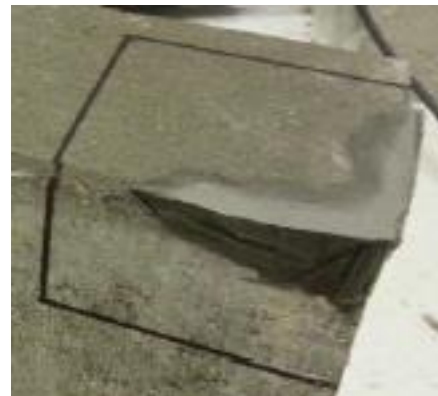
Figure 2. Sample of the PM-P patching mortar for CT Tomography.

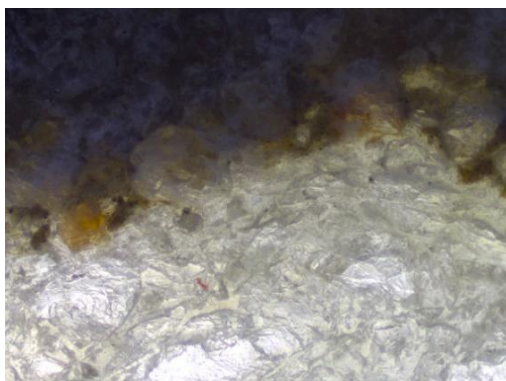
Figure 3. Connection detail of the PM-E reprofiling substance to the concrete base (at the top of the figure) (100x).

4.2.1. *Optical microscope.* From figure 3 and figure 4, it is evident how the epoxy resin, due to its low viscosity, flows into the porous structure of the underlay concrete and thus creates a strong connection at the contact zone. This is very important to ensure good adhesion of the reprofiled mortar to the underlay. The PM-P sample in figure 4 is not sufficiently transparent for viewing in transmitted light, but the interface is visible very well, even in incident reflected light. The figure shows the PM substance in the left lower part, and it is obvious that it is very well grounded in the underlying concrete. In the microscopic observation of the PM-E sample surface (figure 3), it is possible, with transmitted light, to observe in detail the interface of the existing concrete underlay (at the top of the figure), and the polymer concrete patching mortar, due to its high transparency. Furthermore, it is possible to observe the perfect anchoring of the reprofiling substance into the concrete underlay.

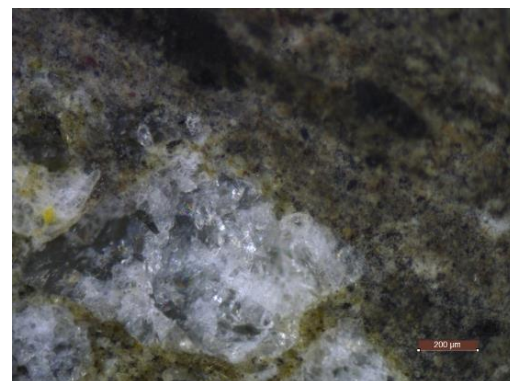
Figure 4. Connection detail of the PM-P reprofiling substance (in the lower left part) to the concrete substrate (100x).

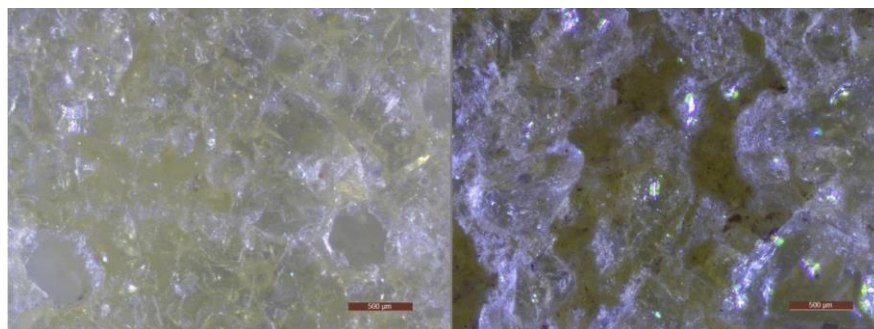
Figure 5. Surface detail of PM-E sample – left sample intact by sunlight (UV rays), UV affected surface can be seen in the right image (50x).

Figure 5 clearly shows the perfect coating of glass shards in an epoxy matrix, which is slightly yellowish. The micrograph in the figure 5 right shows the degradation effect of UV radiation, which affected the applied substance as a result of the exposure of the reprofiled curb to weather effects. Due to the effects of solar radiation, the epoxy matrix decreased slightly as a result of photooxidation (macromolecule breakdown by UV radiation).

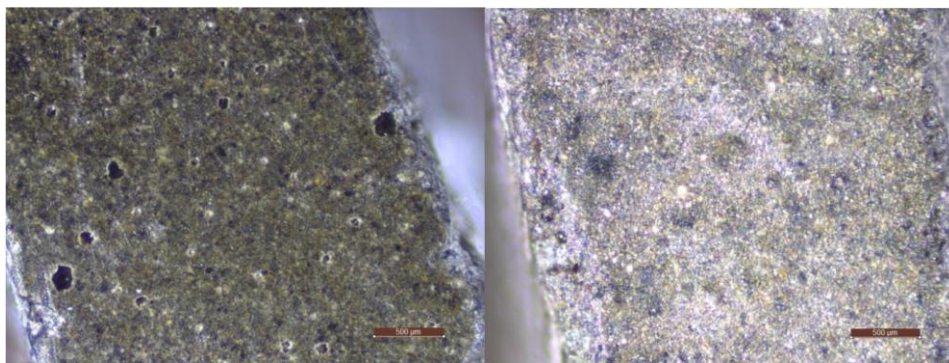
Figure 6. Surface detail of PM-P sample – left sample intact by sunlight (UV rays), UV affected surface by photooxidation can be seen in the right image (50x).

Figure 6 on the left shows the microstructure of the PM-P substance surface, where it is possible to observe the uniform distribution of fly ash grains (cenospheres) in the epoxy matrix. In figure 6 on the right, it is possible to observe the apparent change in the surface of the substance due to photooxidation; this is a sample that has been subjected to weathering for 300 hours.

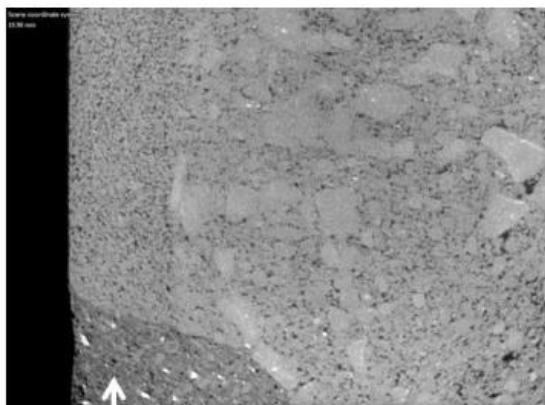
Figure 7. Internal structure of the PM-E substance (indicated by arrow) and detail of connection to the concrete curb.

4.2.2. CT Tomography. From a computer tomography (CT) observation (see figure 7 and figure 8), it can be concluded that the patching mortar is compact in both variants on overall cross-section, shows no cracks, tears or higher porosity or separation of the repairing substance from the underlay, compared to the comparative REF samples. Due to the appropriate viscosity, the substance is firmly anchored to the underlay. Additionally, the PM-P substance had a denser and more compact structure compared to the PM-E substance, which can be said to have higher strength and better long-term durability.

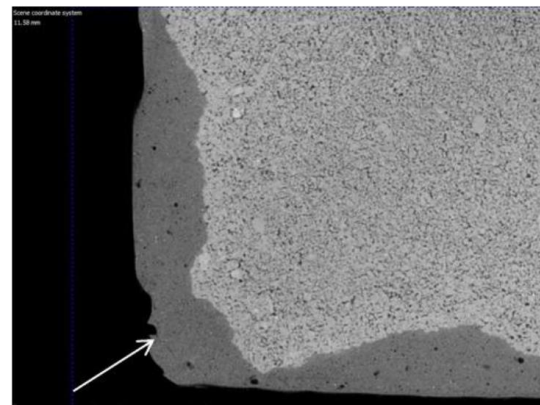
Figure 8. Internal structure of the PM-P substance (indicated by arrow) and detail of connection to the concrete curb.
