21st European Conference on Fracture, ECF21, 20-24 June 2016, Catania, Italy

Stage I fatigue cracking in MAR-M 247 superalloy at elevated temperatures

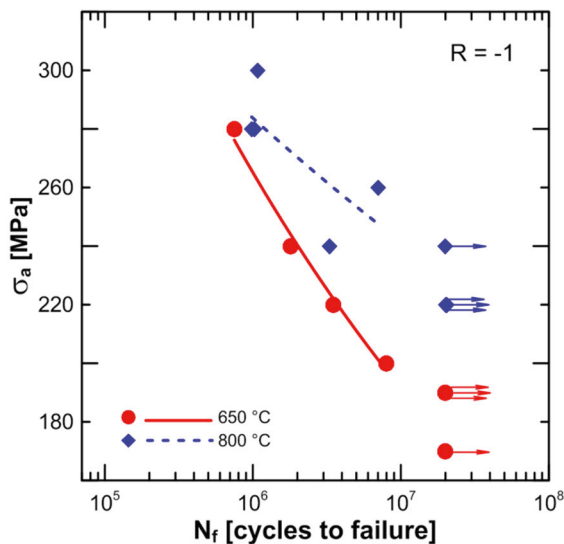
Fig. 2. Fatigue life curves at temperature 650 and 800 °C. Data points with arrow denote run-out specimens.

Figure 2 shows S-N curves determined from HCF tests at 650 and 800 °C. Data points with arrows denote run-out specimens which reached at least 2×10^7 cycles. Experimental data are burdened by significant scatter due to cast nature of the alloy. Despite the scatter and limited number of tests, distinct change in HCF performance can be seen between both temperatures. Lower fatigue limit, 190 MPa, was determined at 650 °C and also fatigue tests from area of finite fatigue life yield noticeably lower number of cycles to failure than HCF tests performed at 800 °C.

The fatigue limit of 220 MPa was determined for this temperature. The diagram also shows distinctively different slopes of both S-N curves.

Presented S-N curves (Fig. 2) show noticeable difference in fatigue behavior of the MAR-M 247 alloy at 650 and 800 °C. Fatigue performance at 650 °C was worse and determined fatigue limit was lower than at 800 °C. The slopes of both curves indicate that different fatigue damage mechanism is dominant for each temperature. Fracture surfaces from tests at 650 °C suggest that strong crystallographic dependence and intense localization of cyclic plastic deformation results in dominant stage I fatigue crack initiation and propagation. Stress concentrators like shrinkage pores have a significantly higher influence on fatigue life under such conditions.
